# **Kelly Creek Fire Post Wildfire Hazard Assessment and Partial Risk Analysis**

## **2009 Fire C40429 near Clinton**

**Prepared for the BC Ministry of Forests and Range**

**December 21, 2009**

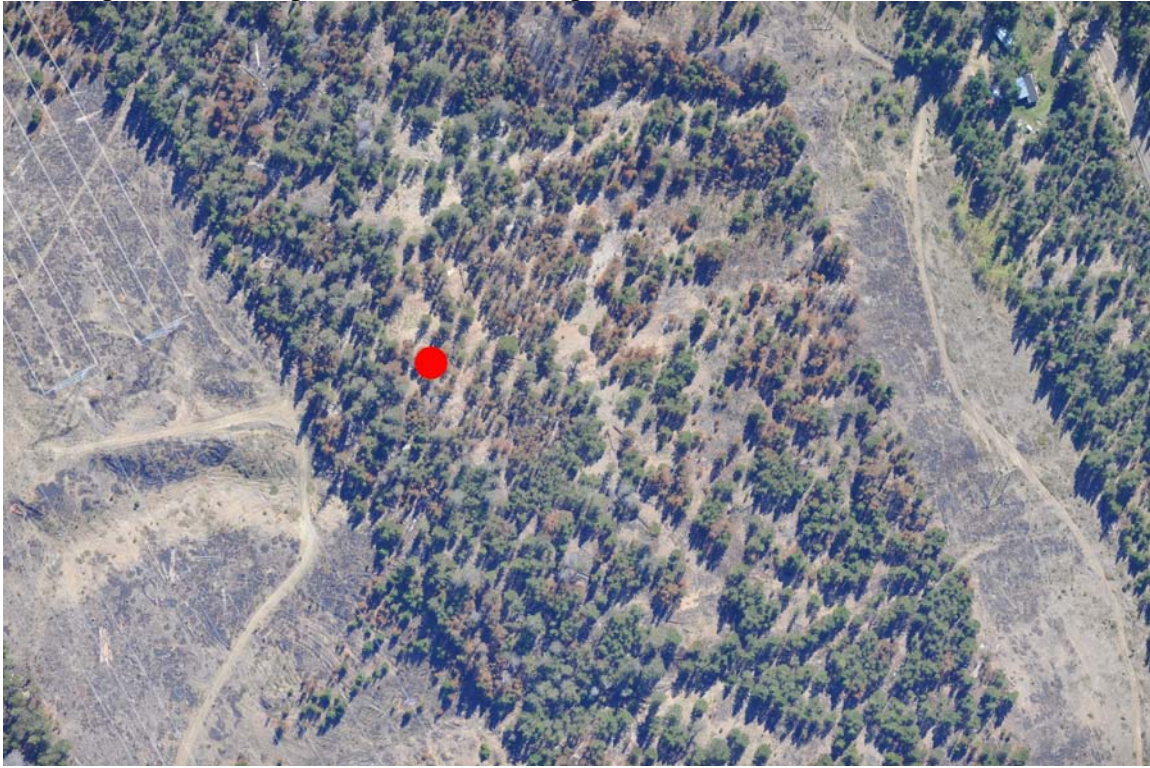
Photo 1- In drainage H2c showing the BARC verification point on a Teti photo.

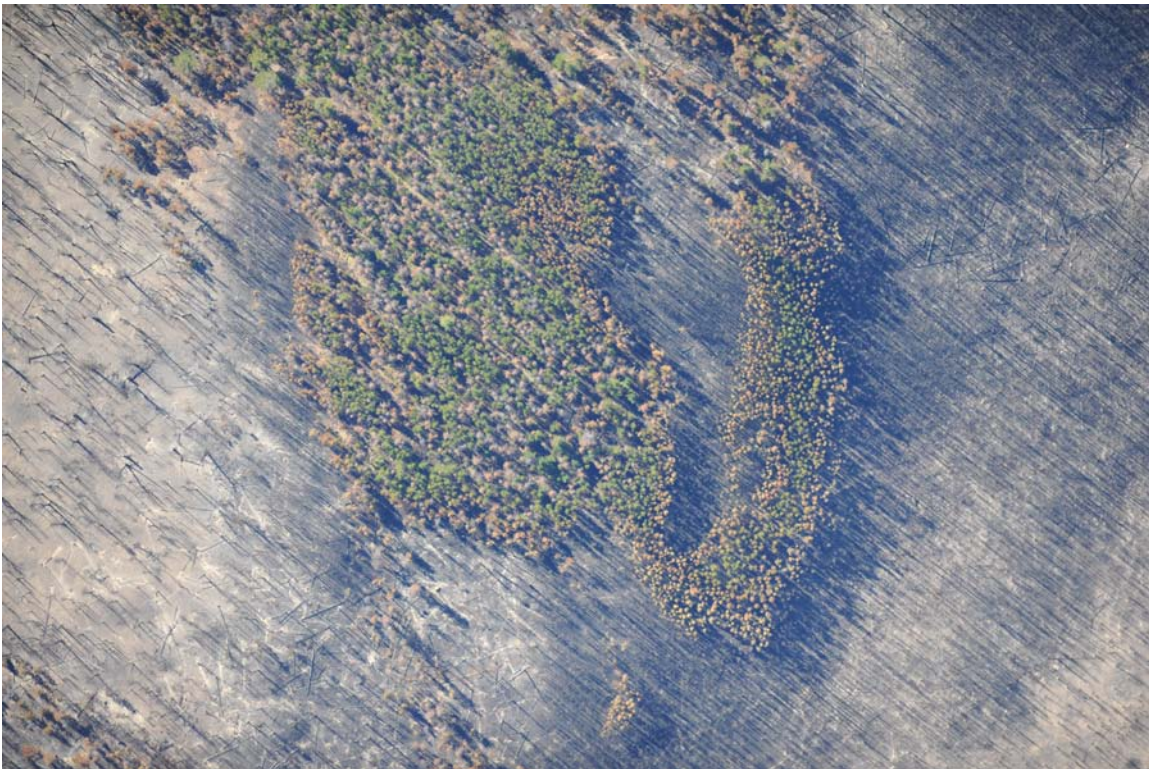
Photo 2- A mixture of high (left), low and unburned (middle) and medium severity burn (right) based on the visual criteria that were used to verify the BARC Map with Teti photos.

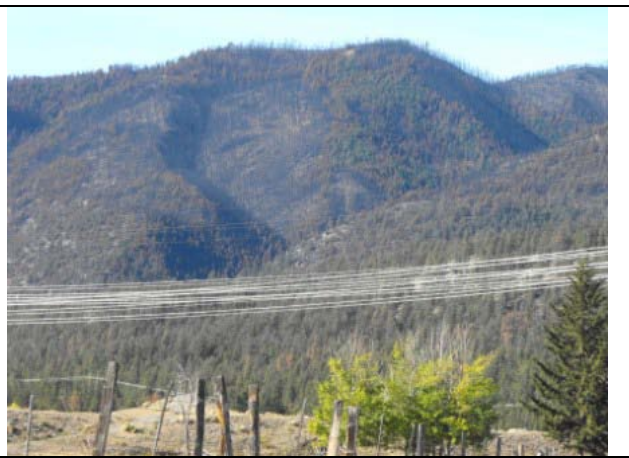
Goodrich Creek is located at the south end of the burn area (Photo 1) and drains into Kelly Lake. Pavilion-Clinton road is located at the base of the Goodrich Creek debris flow fan which has a deposit slope angle of approximately 18% (Photo 2). The Goodrich drainage has an area of 202 hectares and a local relief of 800m with a Melton ratio of 0.56 to 0.58 and may be prone to both debris flows and debris floods. The burn severity score is 53 (see Hazard Likelihood Section) with a hazard rating of high (see Table 1). The shape of the Goodrich Creek drainage (elongated) is such that a tributary creek located at the south end of the drainage could be debris flow prone (area 30 hectares, length 1.1km, relief 500m, Melton Ratio 0.91). Small levees near the apex of the fan, moderate clast size across the fan with occasional large boulders near the apex and weak channel development all support a mix of debris flow and debris flood processes. This tributary drainage also has a very high percentage of high and moderate vegetation burn severity.

<p>Photo 1 Part of H1 watershed (Goodrich Creek)</p>	<p>Photo 2 Goodrich creek fan</p>

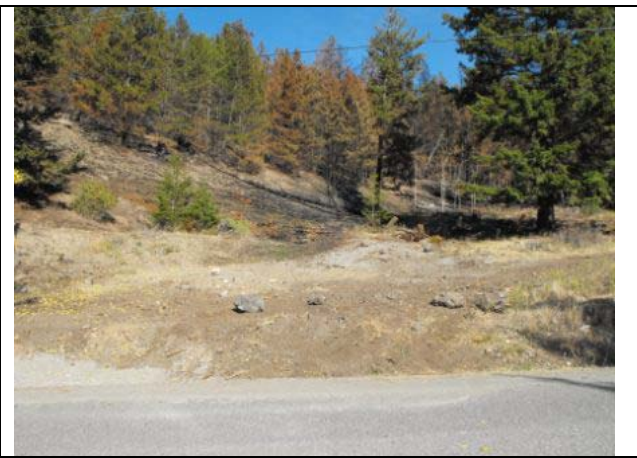
One house (E4 in Table 5) is located above the Pavilion-Clinton road on the fan while another property (E2 - house and mobile home) is located below the road at a location where the fan gradient drops to 9%. A highway rest stop (E1) is located at the fan contact with slopes to the northwest and Kelly Lake to the west. A campground (E3) is located further downslope where the slope gradients drop to 1% (perhaps part of Porcupine Creek flood plain and/or lacustrine deposits). A CN Staging area (E5), with outbuildings, is located half way between Goodrich creek and Porcupine creek below the highway at the east side of the Goodrich creek fan. According to a local resident Goodrich Creek does not normally flow to the highway (subsurface through the fan) and no culverts were observed at the highway location.

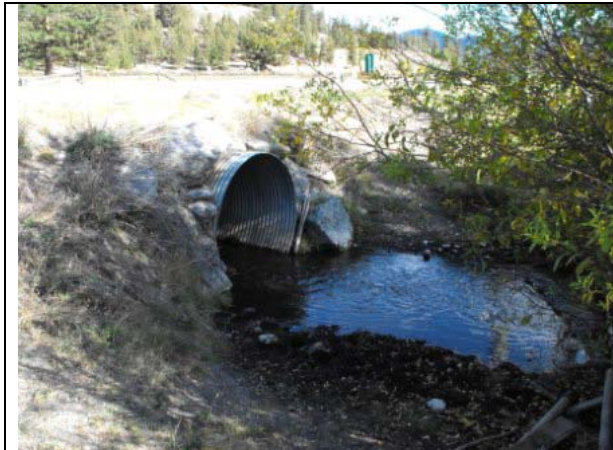
Houses and a ranch (E6) are located above the highway and on the west side of Porcupine Creek. The Porcupine Creek drainage area is 6917 hectares and the creek meanders through private property above the Pavilion-Clinton road and then crosses under the road through an 1800mm culvert (Photo 3) with a 600mm overflow culvert. Some sand/gravel was observed in the overflow culvert indicating past flow activity. Upstream of the highway culvert, Porcupine Creek flows through a culvert on private property (Photo 4) which appears to be about half the size of the highway culvert and could be a potential constriction point.

Photo 3 Porcupine Creek at Pavilion-Clinton Road

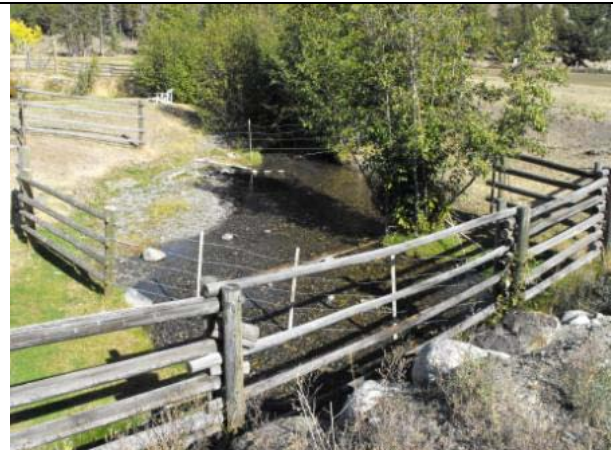
Photo 4 Porcupine Creek on private property

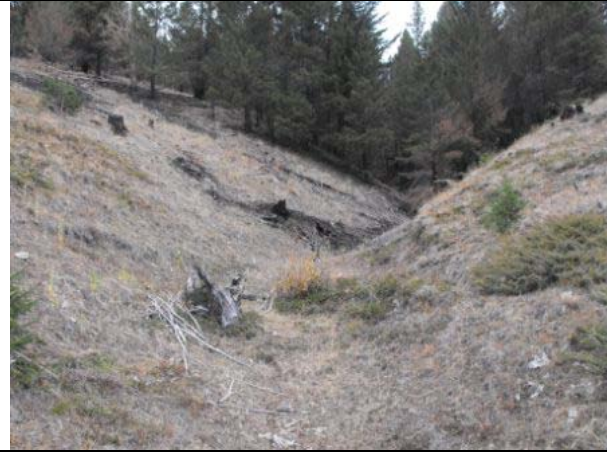
Photo 5 watershed H3a-1

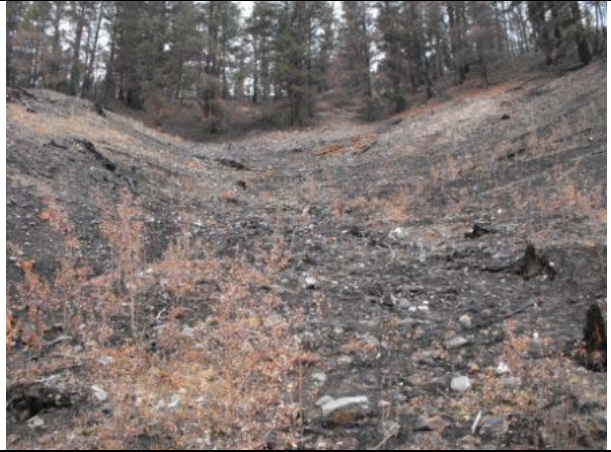
Photo 6 watershed H3a-2

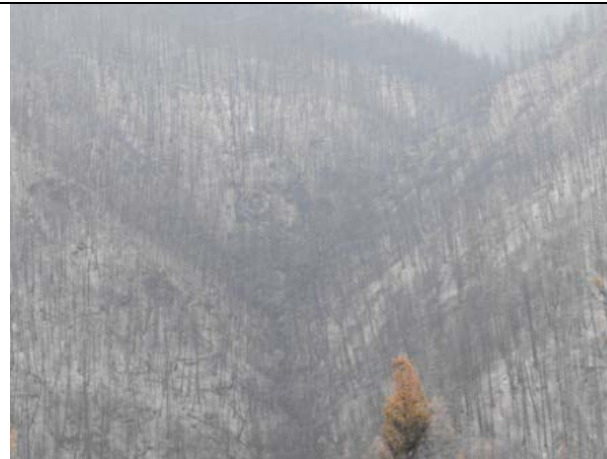
Photo 7 H3b-1 drainage

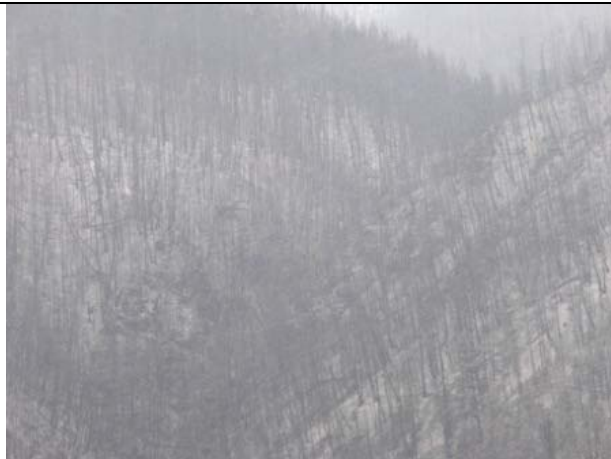
Photo 8 H3b-1 drainage

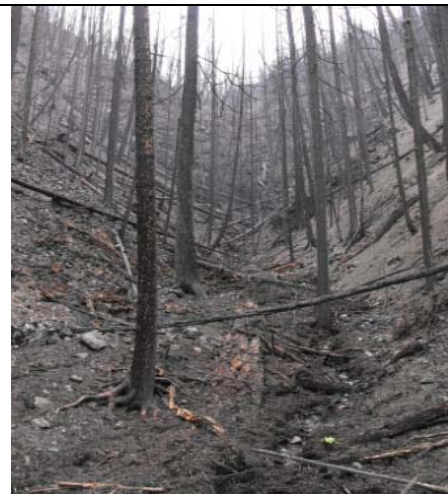
Photo 9 H3b-1 fan apex

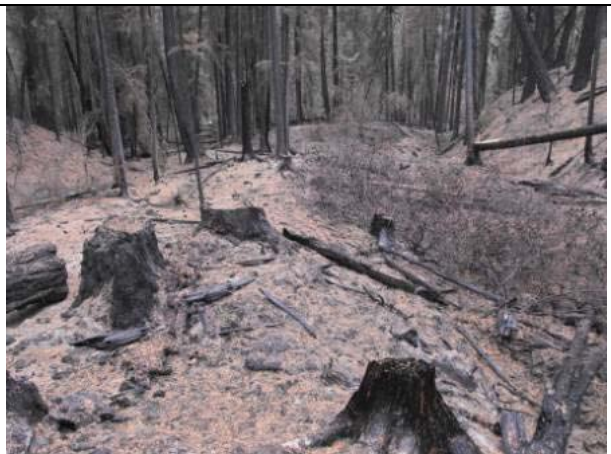
while H2b-3 and H2b-1 have high event likelihood classifications. Melton ratios for these west side gullies range from 0.91 to 1.16. The creek channel of H2b-1 had no creek flow at the time of the field review; however, debris flow levees were observed at the fan location. The house (E10) located on the north side of the Two Mile Creek fan is located about 80m to the east of where the most recent creek flows from H2b-1 reach the distal portion of the fan. The slope gradients from the fan toe to the house are 1% so the house is not located in the direct impact zone. A house (E9) located 130m to the north of H2b-2 and about 250m to the north of H2b-3 and on the Two-Mile Creek fan is about 30m to the east of Porcupine Creek. Two Mile Creek appears well incised at this location. The fans of H2b-2 and H2b-3 were not field reviewed; however, the slopes were walked to a location 100m to the southwest of this house (E9) and the house did not appear to be situated on either the direct or indirect impact zones of either fan H2b-2 or H2b-3. Another house (E11) is located on the Two Mile Creek fan and above the Jesmond Road. This house is exposed to a small gully to the north and to flooding of Two Mile Creek. The event likelihood for the small gully is low while Two Mile Creek drainage has moderate event likelihood.

Photo 10 H3b-1 debris flow levees

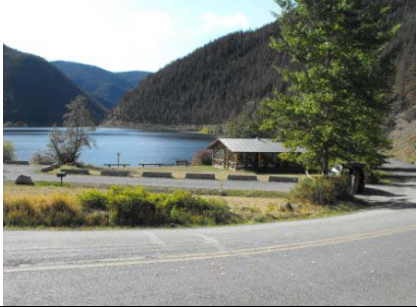
Element Number	UTM	Description	Drainage /Hazard Source and Type	P(H)	P(S:H)	Partial Risk P(HA)	Photo
1	585748/5651777	Highway side rest area located on and adjacent to Goodrich Creek fan.	H1 Goodrich Creek. debris flow/flood	High	Mod.	High

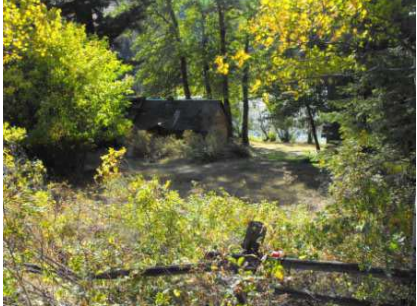
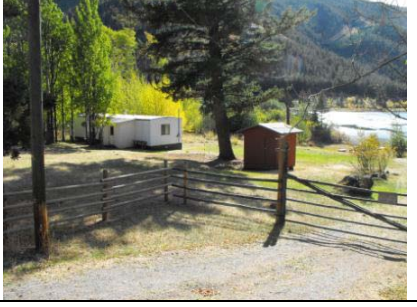
2	585852/5651746	Downing Property -Log House, mobile home and outbuildings located below highway and on Goodrich Creek fan	H1 Goodrich Creek. debris flow/flood	High	Mod	High

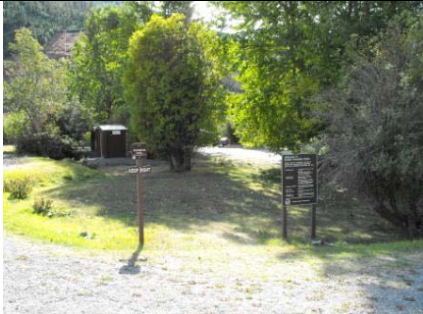
Element Number	UTM	Description	Drainage /Hazard Source and Type	P(H)	P(S:H)	Partial Risk P(HA)	Photo
3	585946/ 5651678	Provincial campground	a)H1 Goodrich Creek - flood b) Porcupine Ck flooding	a)High b)High	a)Low b) Mod	a)Low b)Mod

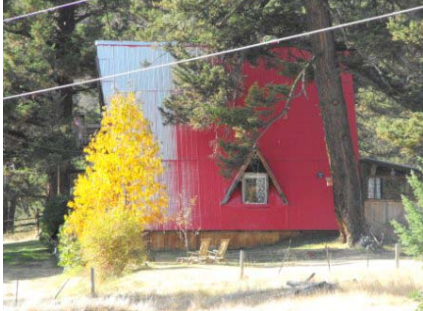
4	585945/ 5651822	A-Frame house and outbuildings located above highway and on Goodrich Creek fan	H1 Goodrich Creek flooding and debris flow	High	High	High

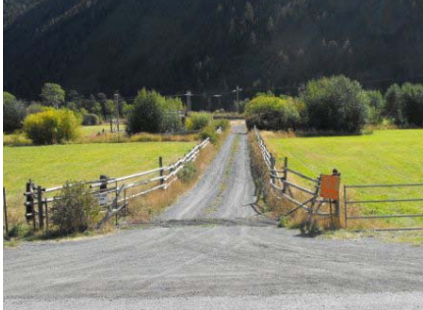
5	586027/ 5651925	Road to CN staging and old outbuilding located below (south of) highway.	H1, a) Goodrich Creek flooding b) Porcupine Creek flooding	a) High b) High	a)Low b) Low	a)Low b) Mod

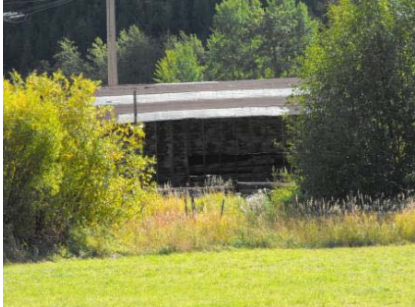
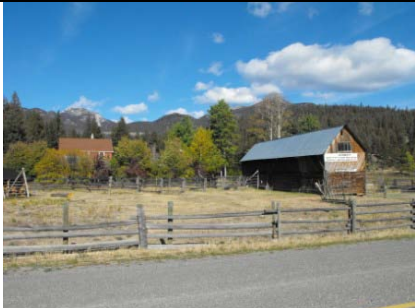
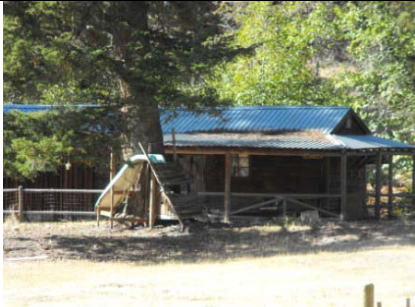
6	586130/ 5651952	Kelly lake Ranch Multiple houses/ outbuildings located adjacent to Porcupine Creek	Porcupine Creek - flooding	High	High	High

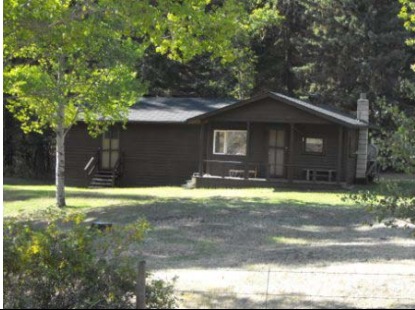
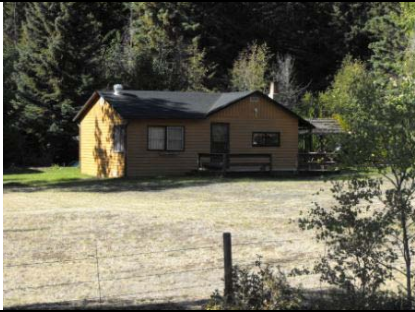
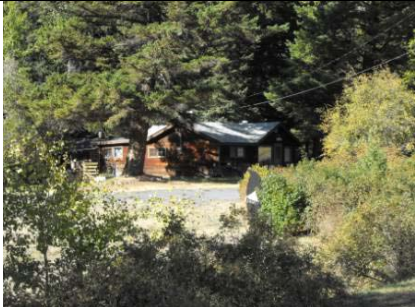
Element Number	UTM	Description	Drainage /Hazard Source and Type	P(H)	P(S:H)	Partial Risk P(HA)	Photo
7	586185/ 5652303	6421 Chevalier Court 5 houses and 2-3 outbuildings or cabins located adjacent to Porcupine Creek	Porcupine Creek - flooding	High	High	High

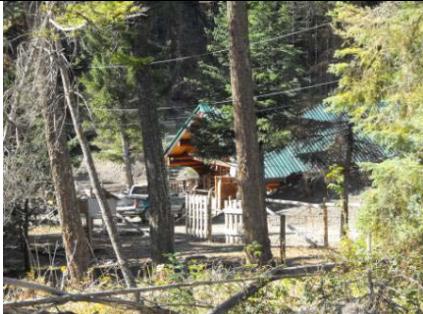
Element Number	UTM	Description	Drainage /Hazard Source and Type	P(H)	P(S:H)	Partial Risk P(HA)	Photo
8	585782/ 5653810	6656 House and out buildings located below and to the west of Jesmond Road	a)H11c debris flow gulley located above Jesmond Road. b)H11a,b Debris flows/slides from west side c)Porcupine ck flooding	a)Low b)Low c) High	a)High b)Low for affecting house c)Low for house	a)Low b) Low c) Low

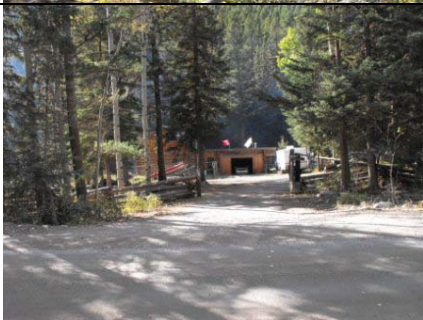
9	585027/ 5654594	6797 House located below Jesmond Road and on the 2 Mile Creek fan	a)Porcupine Creek flooding b)H2a-2 Mile Creek flooding/debris flood c)H2b2-debris slide/H2b3debris flow west slopes	a) High b) Mod c) Mod	a)High b)Mod c)Mod	a) High b) Mod c) Mod

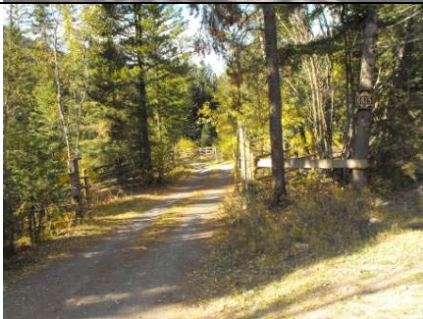
10	585071/ 5654821	6815 House ,barn, outbuildings located below Jesmond Creek road and on 2 Mile Creek fan	a)Porcupine Creek flooding b)H2a-2 mile creek flooding/debris flood (house located at edge of fan) c)H2c - debris flow from adjacent drainage to H2c east slope d)H2b1 debris slide/flow west slope	a) High b) Mod c) Low d) High	a)High b)Mod c)High d)Low	a) High b)Mod c)Mod d)Mod

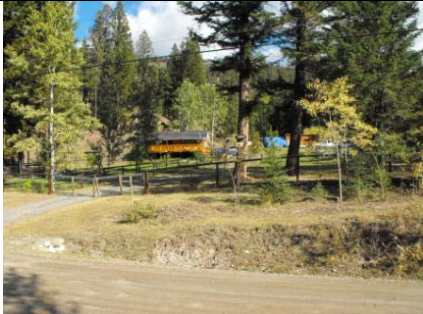
Element Number	UTM	Description	Drainage /Hazard Source and Type	P(H)	P(S:H)	Partial Risk P(HA)	Photo
11	585122/ 5654678	6808 House and outbuildings located above Jesmond road and on the 2 mile Creek fan.	a)H2a 2 Mile Creek flooding/debris flood b)debris flow from small gulley to the north	a)Moderate b)Low	a)Mod b)Low	a)Mod b)Low

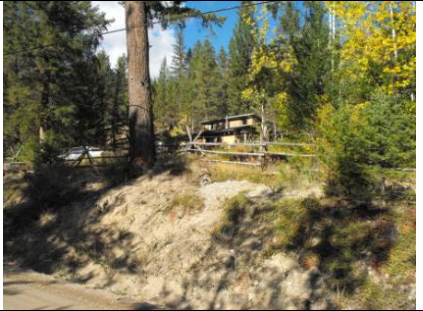
12	585071/ 5654821	6820 House located above Jesmond Road and to the north of the 2 mile creek fan	H2c Debris Flow from adjacent drainage to H2c	Low	High	Mod

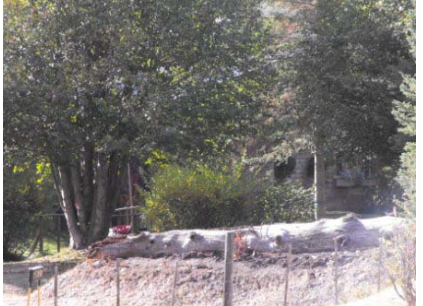
13	584718/ 5655029	6853 “Alan Park” House located on west side of Jesmond Road and Porcupine Creek	a)Porcupine Creek flooding b)H3a2 Debris flow gulley on east slope c)H2b1 Debris flow/slide west slope	a) High b) Low c) High	a)High b)High c)Low	a)High b)Mod c)Mod

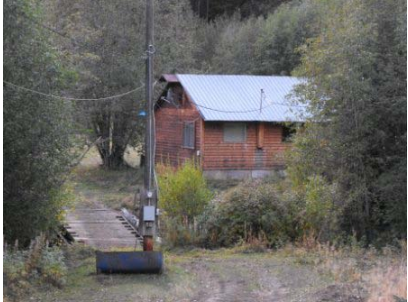
Element Number	UTM	Description	Drainage /Hazard Source and Type	P(H)	P(S:H)	Partial Risk P(HA)	Photo
14	584570/ 5655126	2 <sup>nd</sup> prop Alan Park House and mobile home	a)Porcupine Creek flooding b)Debris slide east slope c)H3b2 Debris flow/slide west slope	a) High b) Low c) High	a)High b)Low c)Low	a) High b) Low c) Mod

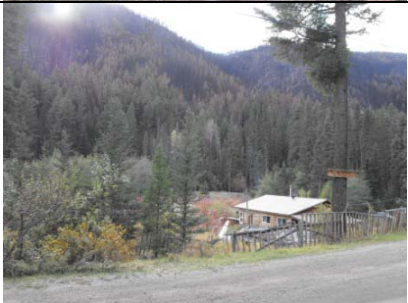
15	584507/ 5655172	6889 House located to west of Jesmond road but east of Porcupine creek	a)Porcupine Creek flooding b)H3a1 Debris flow gulley on east side c)H3b1 Debris Flow west slope	a) High b) Low c) High	a)High b)High c)Low	a) High b) Mod c) Mod

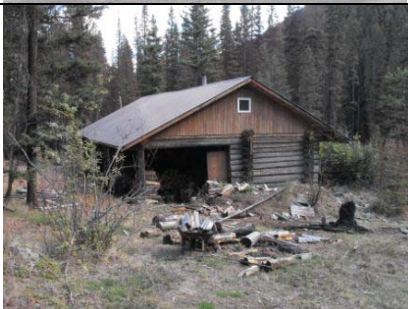
16	583907/ 5655510	Cabin located below Jesmond Road	a)H9a Debris flow/slide from west side of Porcupine Creek b)Porcupine Creek flooding c)H9b debris flow east side	a) High b) High c) High	a)Mod b)Mod c)High	a)High b) Mod c)High

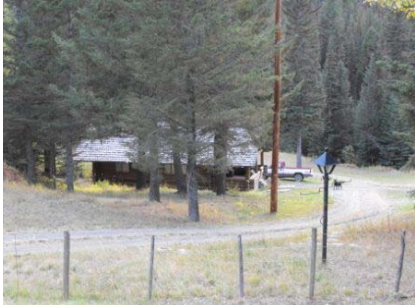
Element Number	UTM	Description	Drainage /Hazard Source and Type	P(H)	P(S:H)	Partial Risk P(HA)	Photo
17	583638/ 5655869	6977 The Masons House and out buildings to west of Jesmond road	a)Porcupine Creek flooding b)H4b Debris flow from gulley to north west c)Debris slide to west d)H4a Two debris flow gullies from east side of Jesmond road	a) High b) High c) Mod d) Mod	a) Low for house (outbuildings?) b)Low for house c)Low for house d)Low to moderate for house	a)Mod b)Mod c).Mod d)Mod

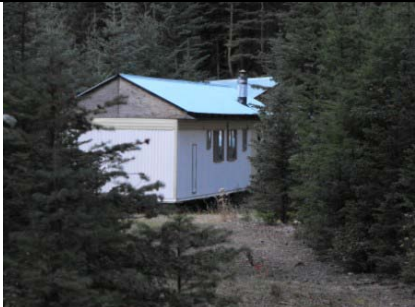
18	582257/ 5657784	Jim and Grace Barnum Mobile Home on west side of Porcupine Creek	a)H8a Porcupine Creek Flooding b)H5 Debris slides from west side of valley	a) Mod b) High (mod for debris slide?)	a)Mod b)High	a)Mod b)High

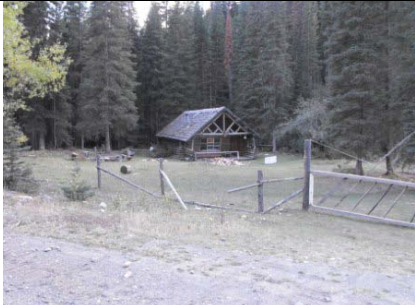
19	581996/ 5658219	Cabin located to west of Jesmond road and north of Porcupine Creek junction with no-name creek	a)H8a Porcupine creek and no-name creek flooding b)H8b Debris flow from west side of valley	a) Mod b) High	a)Mod b)Mod	a)Mod b)Mod

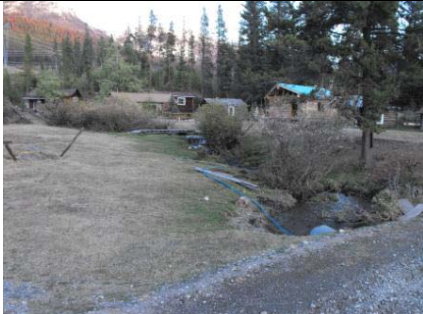
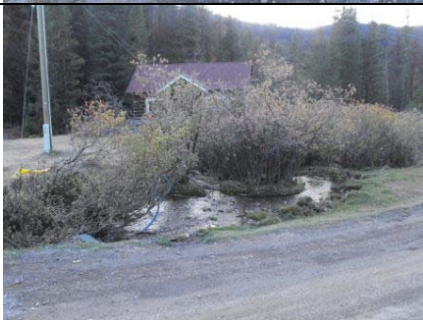
Element Number	UTM	Description	Drainage /Hazard Source and Type	P(H)	P(S:H)	Partial Risk P(HA)	Photo
20	577697/ 5664122	Several cabins adjacent to a tributary creek of Kosterling Creek, flowing from the east	a)H6a Creek flooding b) Kosterling Ck Flooding	a) Low b) High	a) High b) Low to mod	a) Mod b) Mod

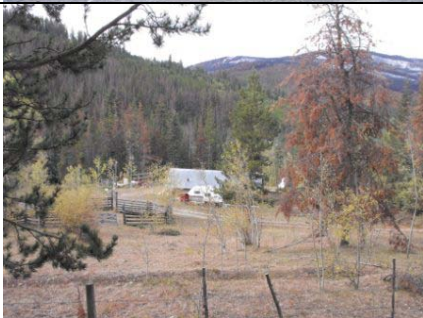
21	575865/ 5666132	House adjacent to a tributary creek of Kosterling Creek, flowing from the east	H12 Creek flooding or debris flow	Low	High (did not determine channel height adjacent to house)	Moderate

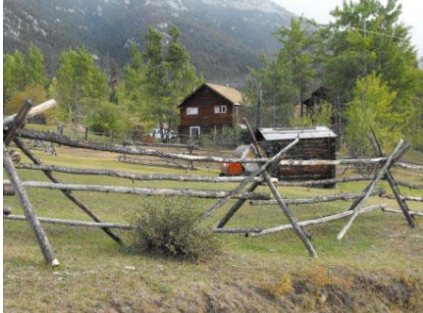
Element Number	UTM	Description	Drainage /Hazard Source and Type	P(H)	P(S:H)	Partial Risk P(HA)	Photo
22	574382/ 5668163	Circle H Mountain Lodge House, cabins, outbuildings adjacent to a tributary creek of Kosterling Creek, flowing from the east	H7 Creek flooding	High	High (did not determine channel height adjacent to house)	High
